Fiskville

Understanding the Past to Inform the Future

Report of the Independent Fiskville Investigation

June 2012

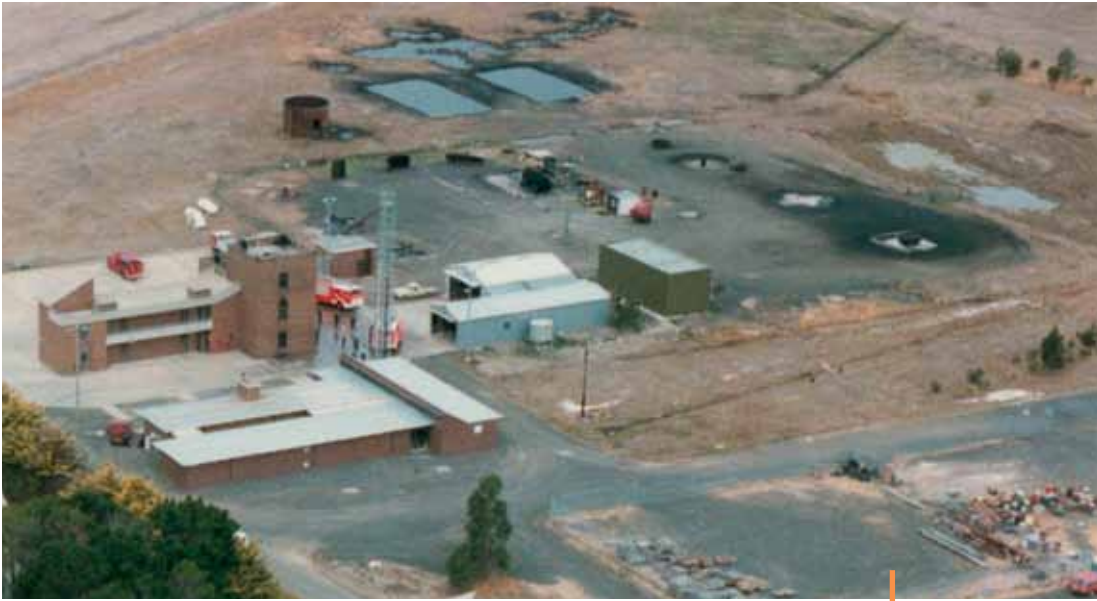
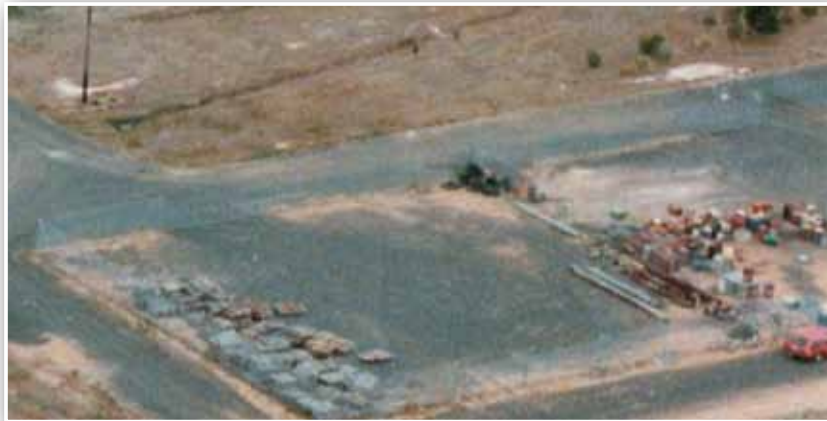
Figure 5.3 Main training area circa 1985. Enlarged area below shows drum pallet and tyre storage areas.
Photo courtesy of CFA

During the 1970s and 1980s, the drum storage area lacked hard standing, protective bunds and overhead cover (Figure 5.3). Access to this area was not restricted by fencing in the early days, as is evidenced by reports of children of Fiskville residents playing in the drum storage area, but a fence had been erected by 1985 (Figure 5.3).

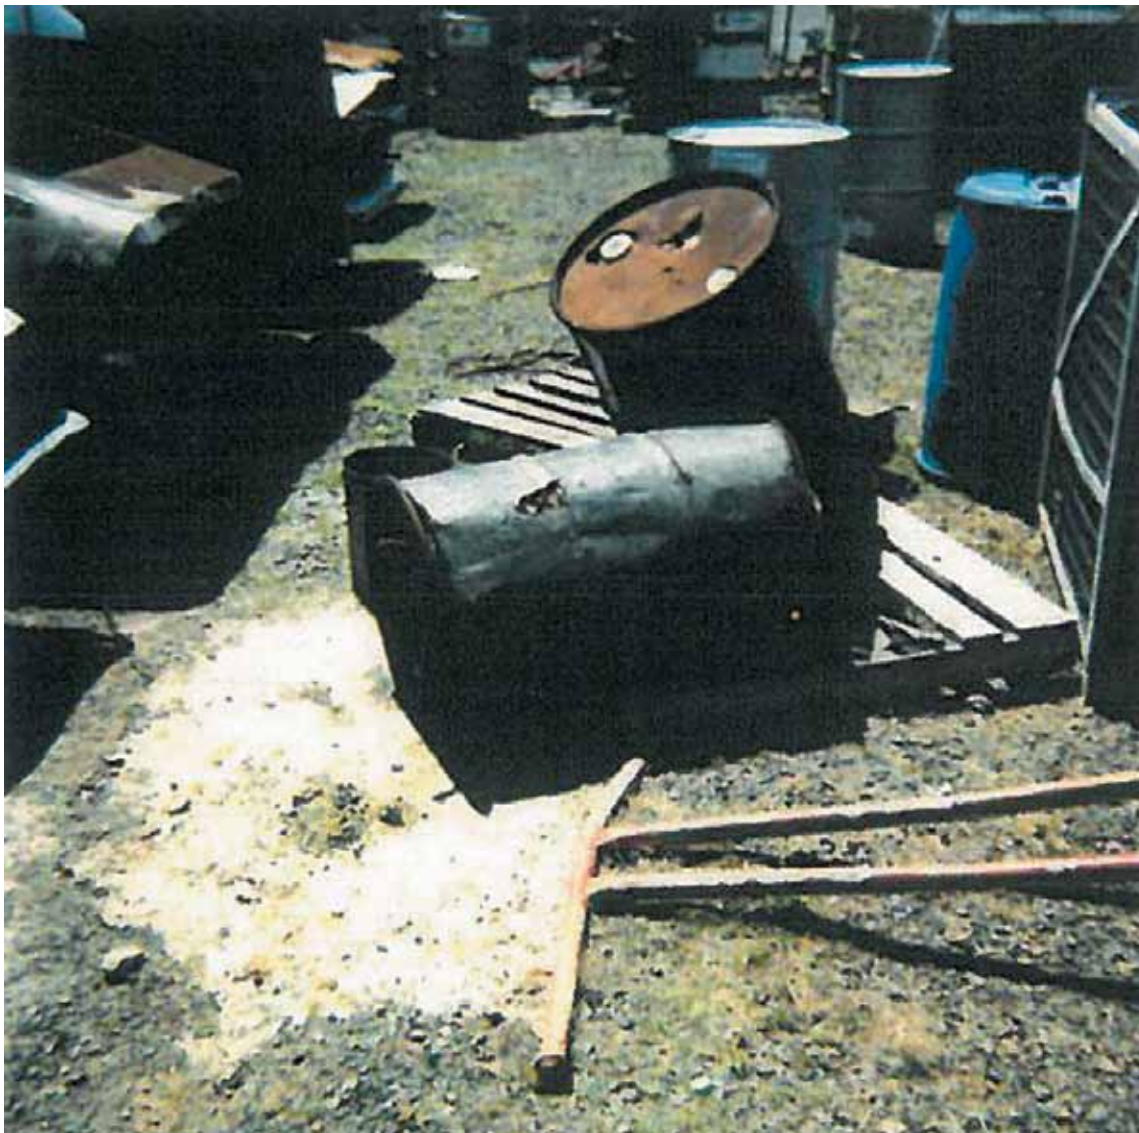
Drum storage area, 1996. Photo courtesy of CFA

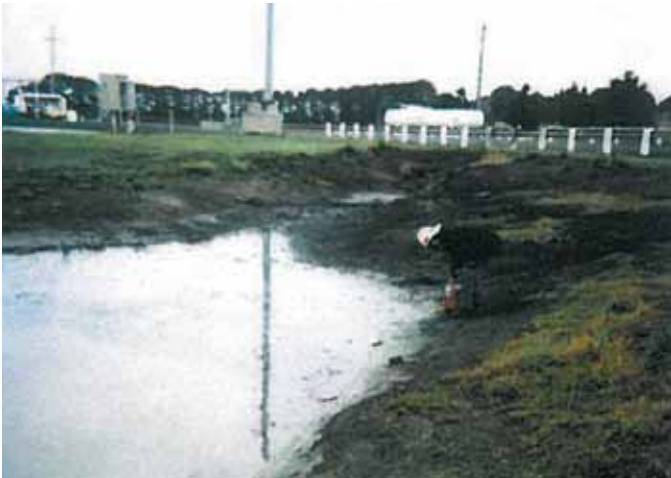
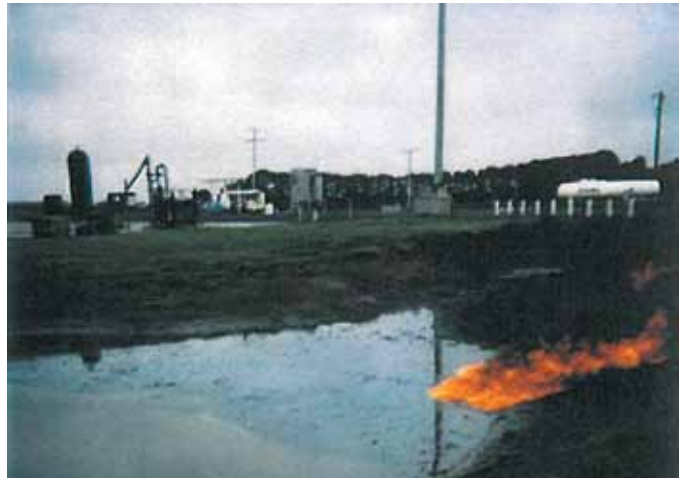
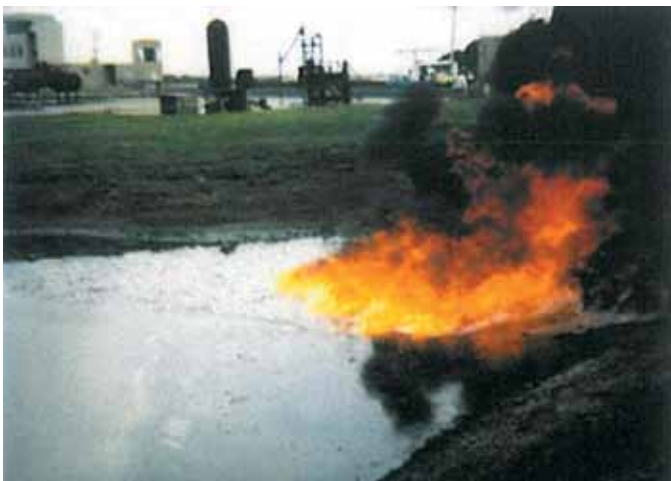
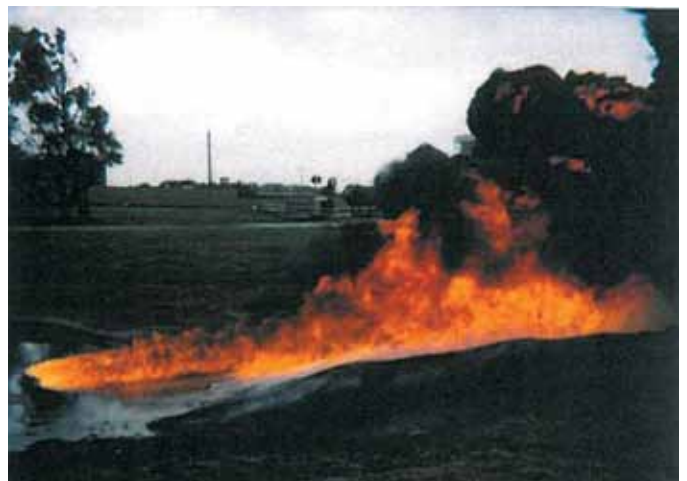
**Burning Off Fuel Residue From Dam 1, adjacent to the flammable liquid PAD in 1996.
Photos courtesy of CFA**

PAD operator pouring approximately 5 litres of petrol on to the surface of the dam to 'prime' it.

Approximately five minutes after ignition.

Approximately ten minutes after ignition.

Approximately 20 minutes after ignition. The dam was observed to burn for approximately 4 hours.

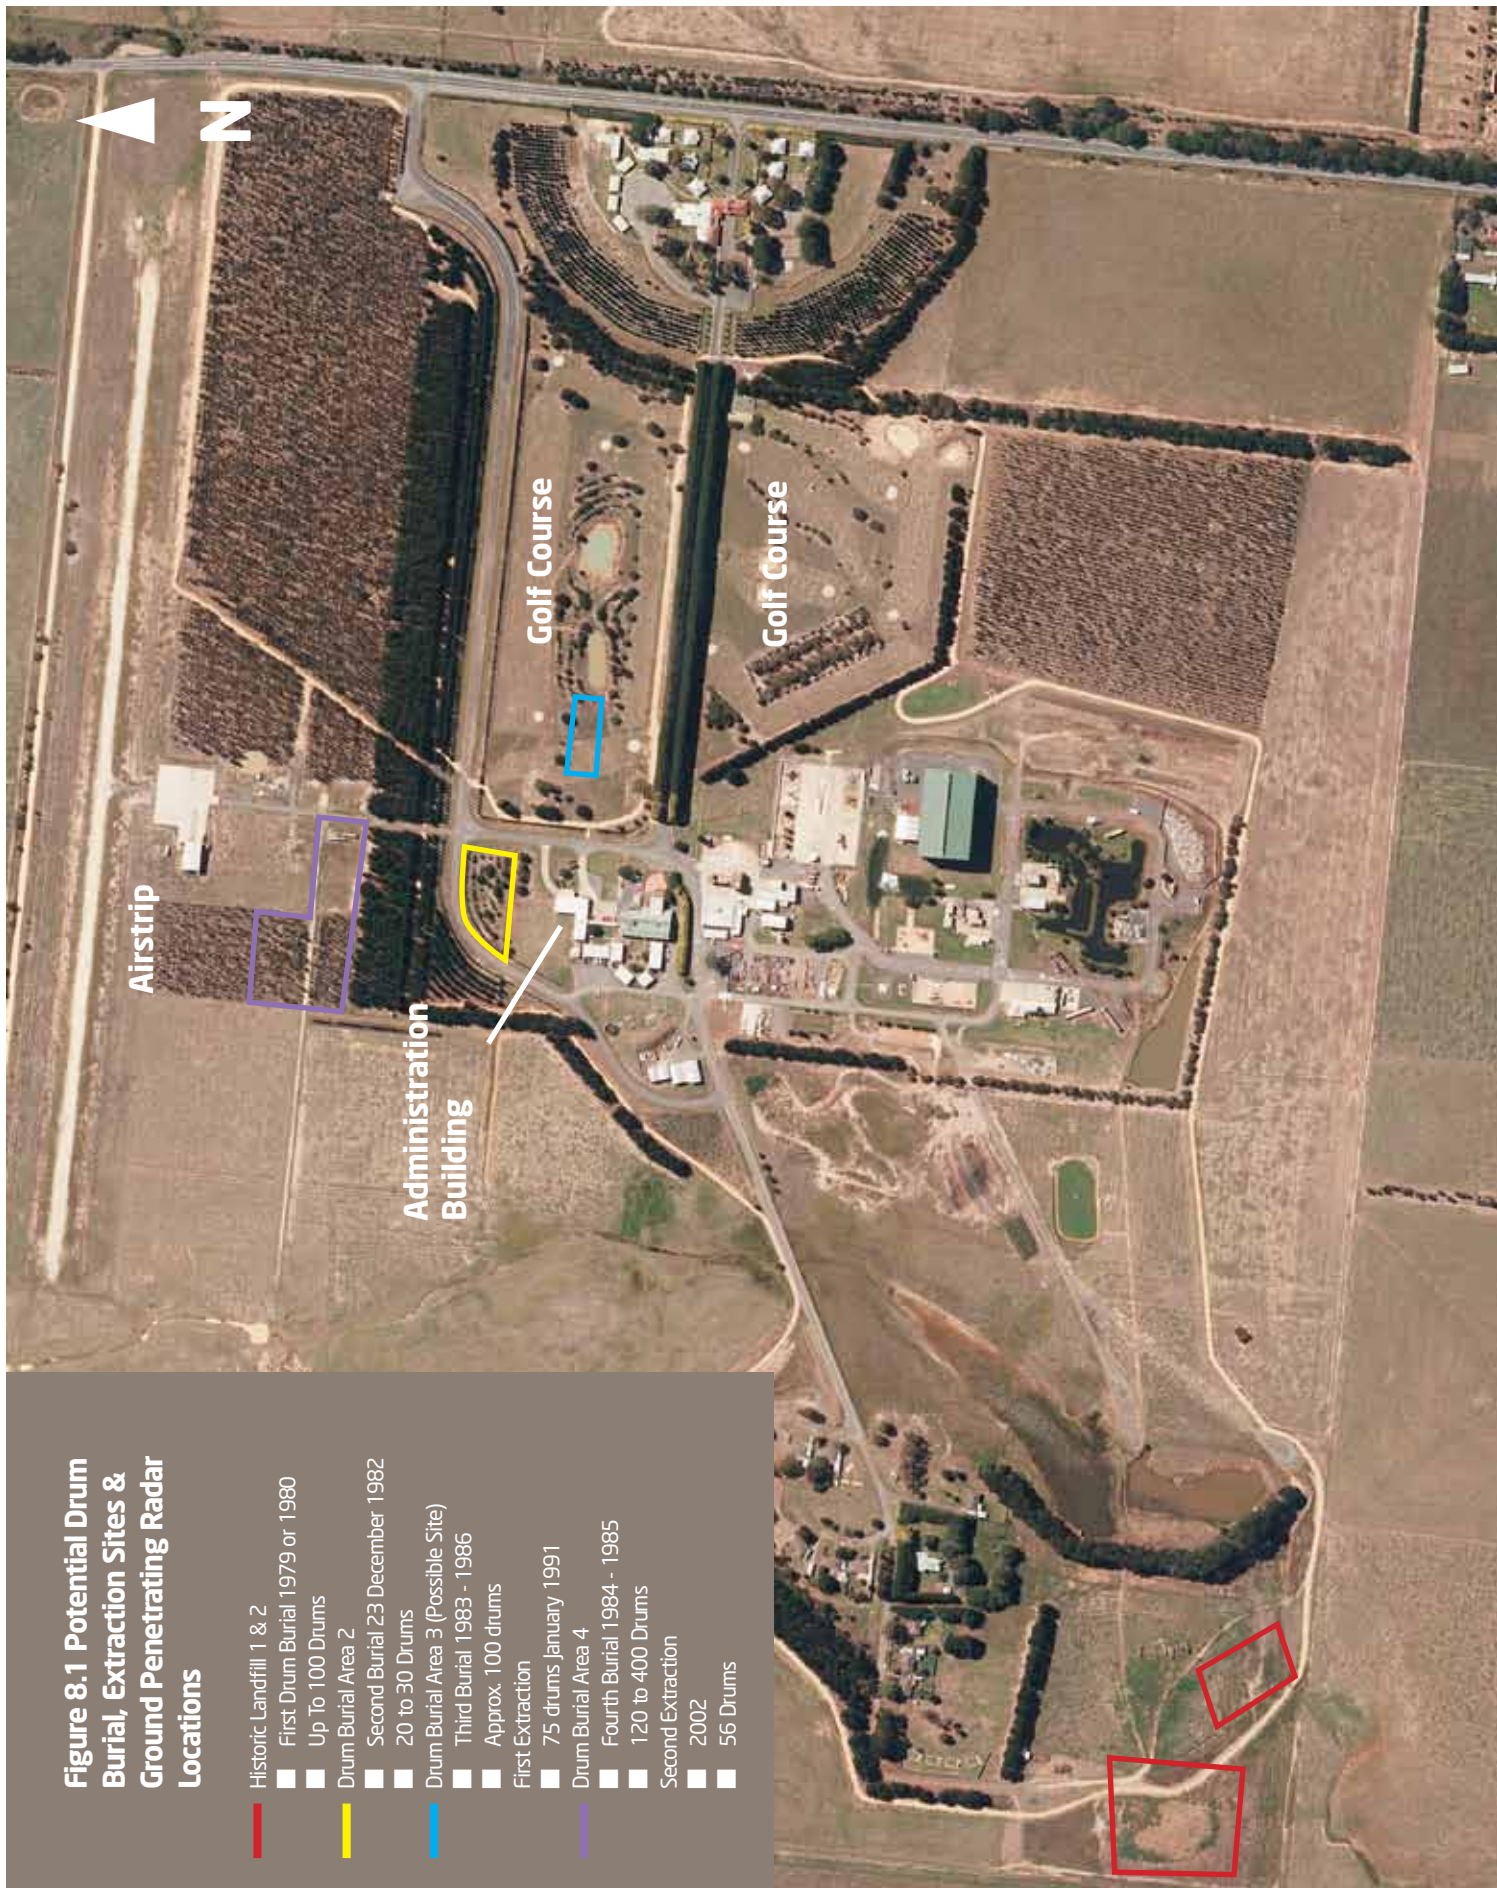
Figure 8.1 Potential Drum Burial, Extraction Sites & Ground Penetrating Radar Locations

Information from a significant number of ex-Fiskville PAD operators and instructors makes it clear that, while the practice of accepting and burying drums varied over this period, it originated and was conducted primarily at the local level. Until 1987, when the Investigation has evidence of corporate awareness of the response to the burial of drums following a fire on 22 December 1982,^[7] knowledge of the practice appears to have been limited to staff and management at Fiskville. This lack of corporate awareness reflects the operational independence of Fiskville management and a lack of corporate environmental or safety systems through this period.

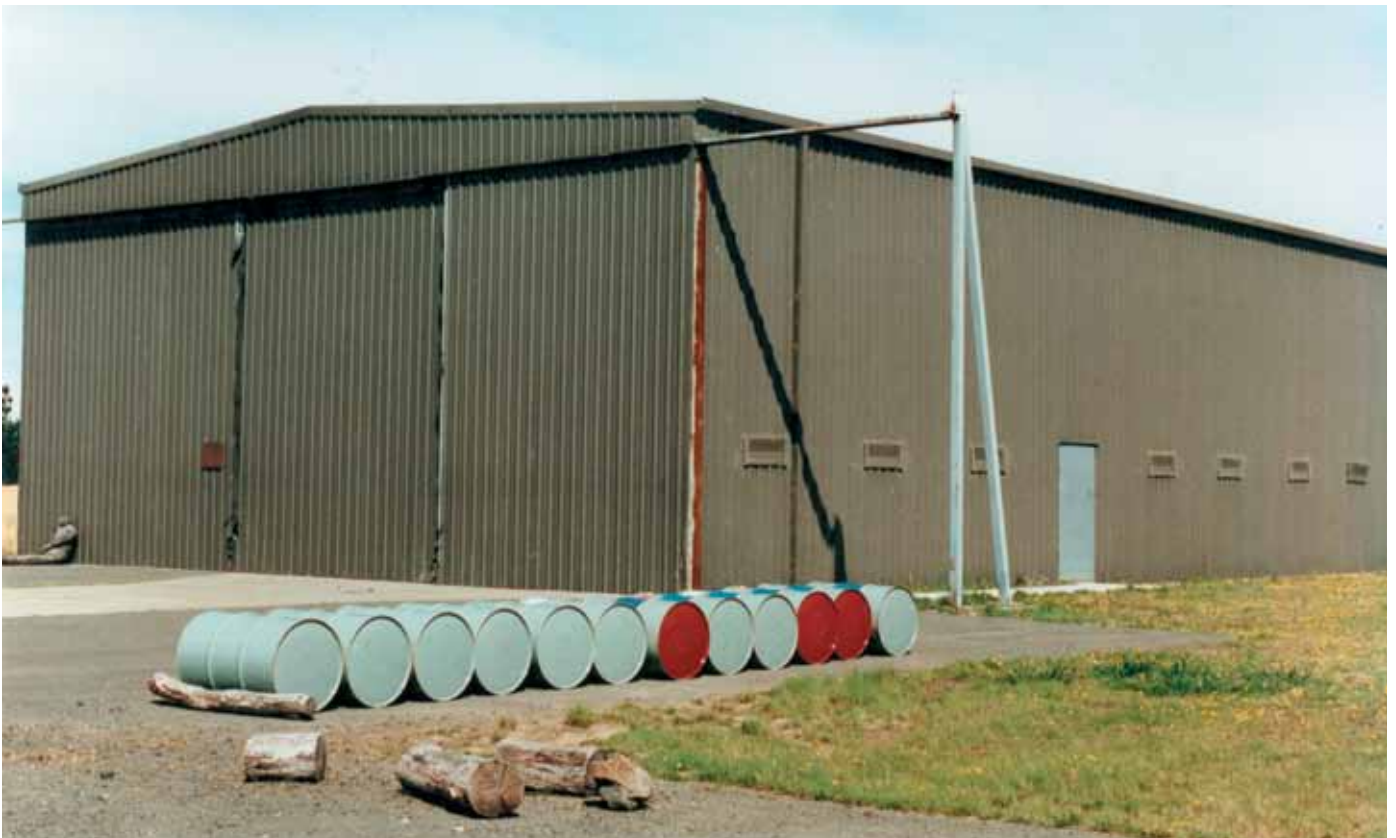
Avgas storage at Fiskville, non-compliance with Bureau of Air Safety, 1995/96. Photo courtesy of CFA
