HAZCON Pty Ltd

HEALTH AND SAFETY REVIEW – CFA FISKVILLE TRAINING COLLEGE

Report Number: 12-0127

January 2012

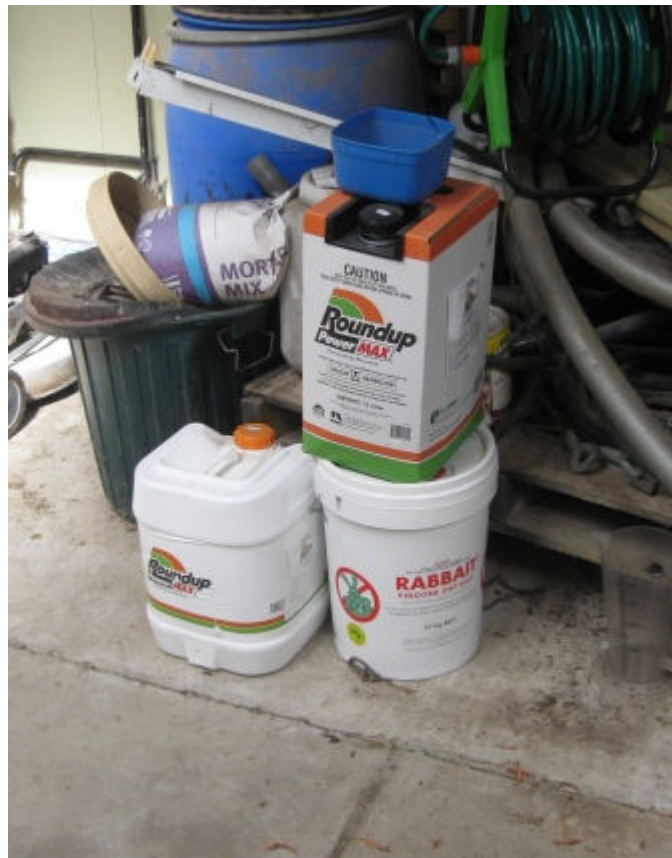
The ground maintenance workshop has a range of small package dangerous goods and hazardous substances and agricultural chemicals. The storage of these is not well executed nor is the labelling of containers with agricultural chemical blends. Poisons such as Pindone should be locked in a secure cabinet. **Refer Photograph 1** The mixed herbicides should have a label on the container to prevent inadvertent use or exposure. **Refer Photograph 2**

Photograph 1 Unsecured poison

4. Storage of chemicals in the grounds workshop to be improved and poisons secured in cabinets.
5. Labelling of chemical spray containers should be implemented.

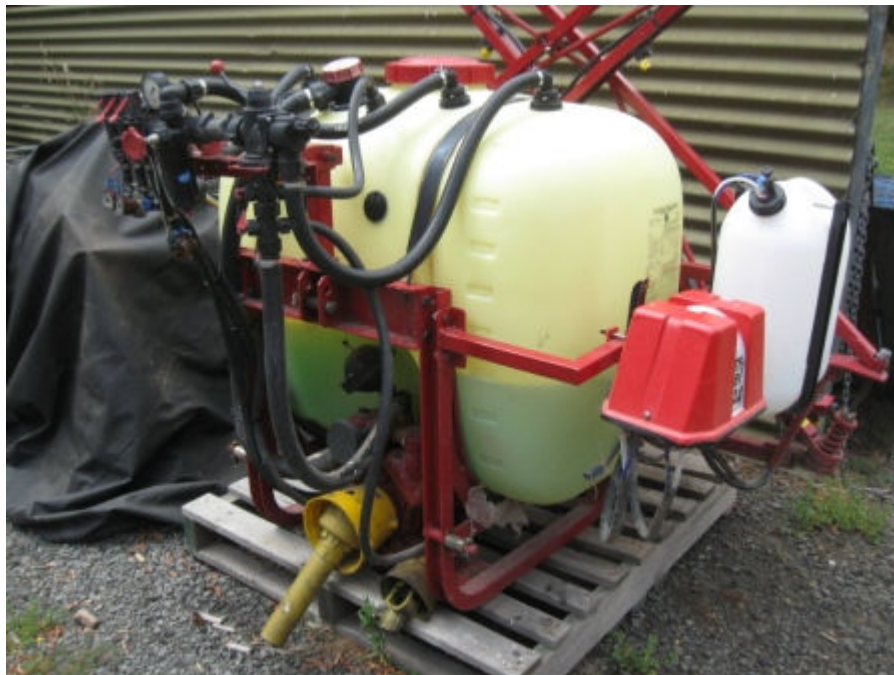
Photograph 2 Unmarked herbicide mixture

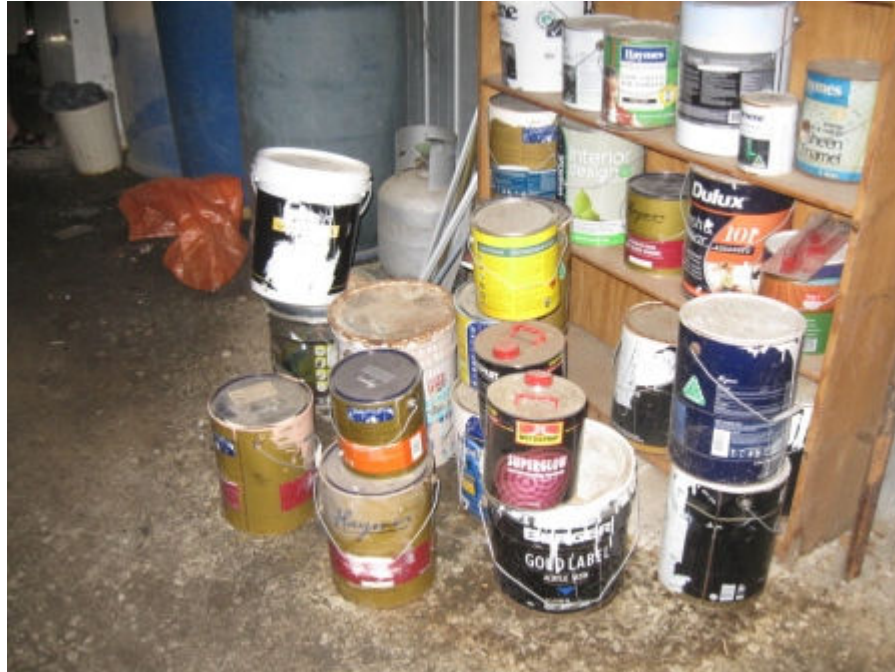
The general maintenance workshop's housekeeping should be addressed as there are a large number of chemical containers that are poorly stored. The floor is earth/crushed rock and is unsuitable for storing chemicals as a leak will contaminate the soil. **Refer Photograph 3** An impervious floor should be in place where chemicals are stored.

Photograph 3 Inappropriate surface for storing chemicals

1. Risk assessments for LPG, diesel and unleaded petrol used on site should be conducted and address all aspects of storage and handling including delivery, maintenance of pipe work etc.
2. The ripping saw guarding to be addressed.
3. The general maintenance workshop floor should be sealed especially in the area where chemicals are stored.

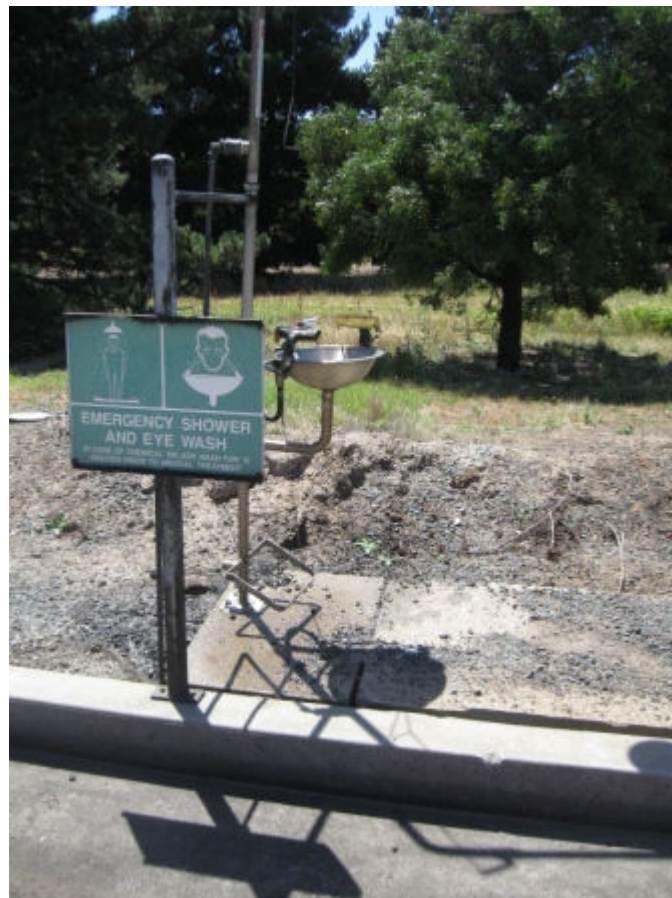
Emergency eye wash and showers were located at either end of the fire fighting area. One emergency shower is poorly maintained **Refer Photograph 4** and pipe work is exposed to the elements. The pipe work should be lagged with insulation and the area beneath the shower levelled.

Photograph 4 Unlagged pipework and rough surface

8. The emergency shower pipe work to be lagged and the rough surface repaired.
9. Introduce housekeeping standards for the workshops and the fire extinguisher fill room.

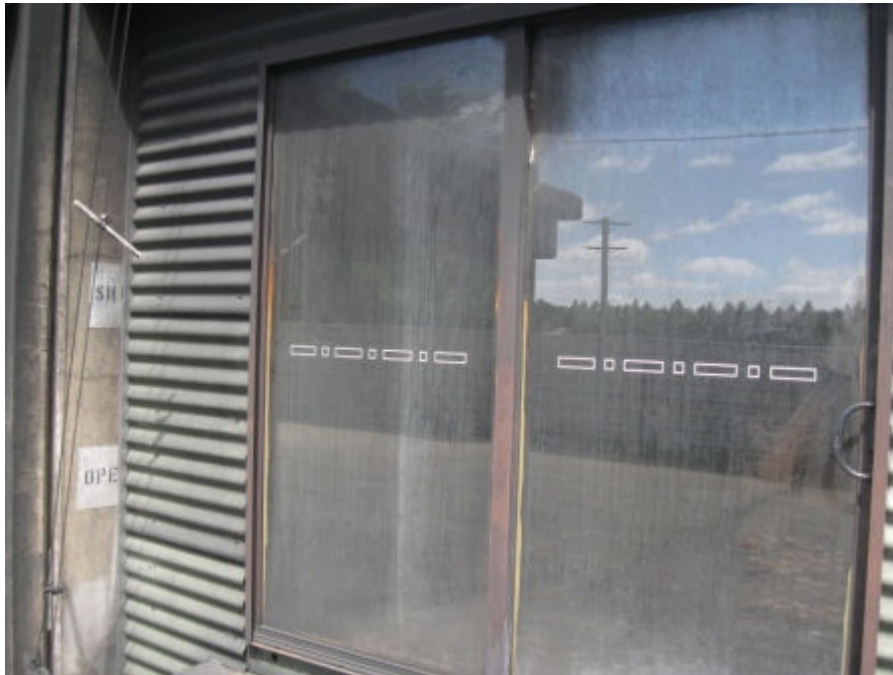
Other buildings are used for fire investigation training and others are for fire response and rescue are supplied by smoke and heat coming from separate cribs attached to the structure. The only concern is whether the glass sliding doors in the double storey and single storey fire attack building is shatter proof if the heat profile gets too high. **Refer Photograph 5** The glass does not appear to be fire resistant and therefore may fail catastrophically during an exercise.

Photograph 5 Glass door on single storey fire attack building

10. Determine whether the glass in the fire attack buildings is at risk of shattering. VUT researchers may be able to provide guidance.
11. The gas cylinder stands at the rear of the maintenance workshop to be repaired.

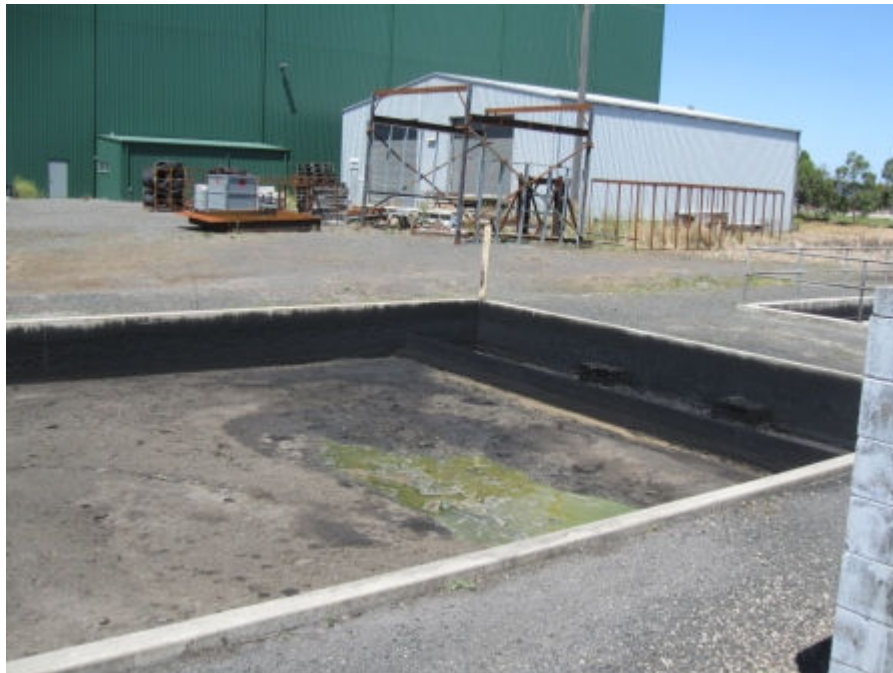
Contaminated fire fighting water from exercises runs into a triple interceptor pit **Refer Photograph 6** and the water then passes into Dam 1 **Refer Photograph 7** which is essentially a settling pond but is also aerated to hasten the degradation of organic residues. Water from Dam 1 then passes through to Dam 2

Photograph 6 Triple interceptor pit for fire water run-off

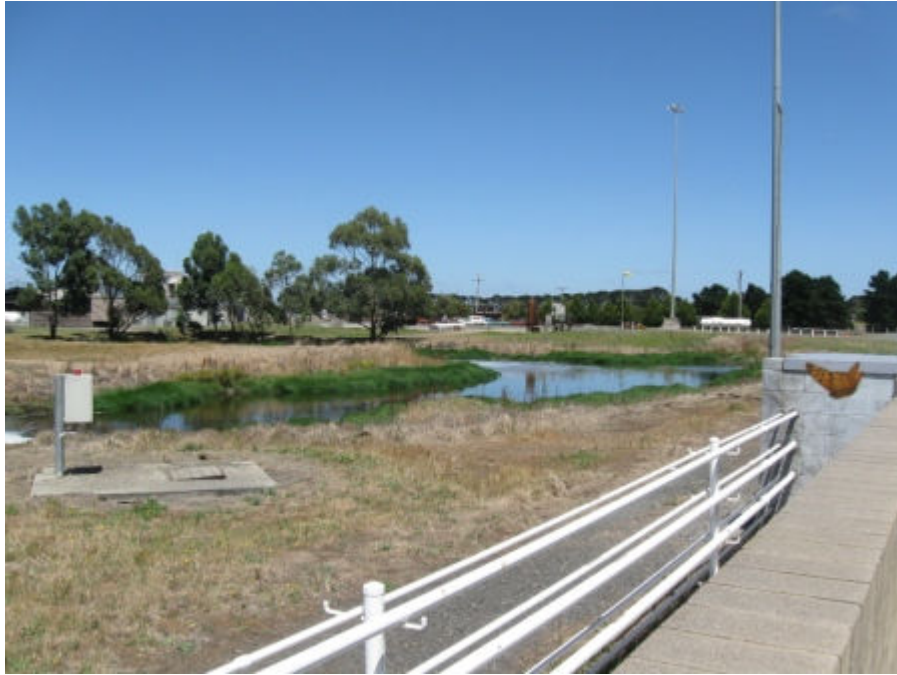
Photograph 7 Dam 1
