# HAZCON Pty Ltd

## **HEALTH AND SAFETY REVIEW – CFA BANGHOLME TRAINING GROUND**

Report Number: 12-0260 Final

February 2012

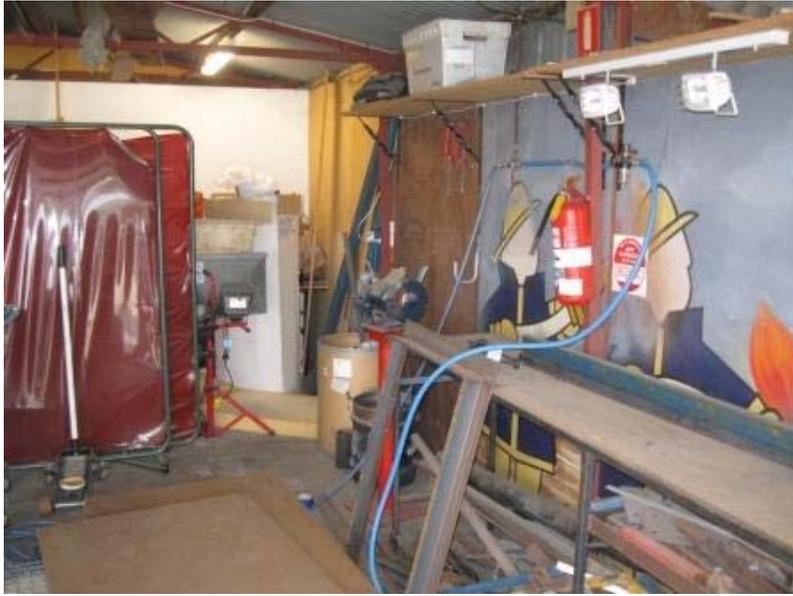
A maintenance workshop is used for supporting minor building works, repairs and ground maintenance. The housekeeping in this building is poor and some of the machinery and storage practices require improvements. **Refer photographs 1 and 2.** The grinder did not have an eye shield on the grinding stone wheel and the metal saw guard did not appear to engage adequately. The floor was covered in off-cuts of wood and the area was generally in need of a housekeeping review.

Photograph 1 Grinder and Workshop Housekeeping

2. Review bund requirements in line with AS 1940-2004 and address.
3. Ensure the saw and grinder guarding in the workshop is addressed.
4. Initiate housekeeping audits against minimum standards in the workshop

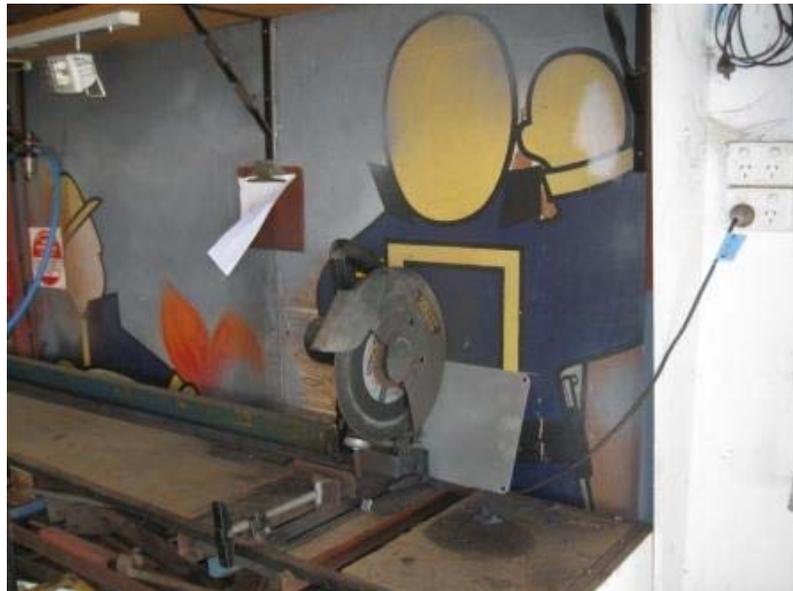
Photograph 2 Faulty guarding on saw

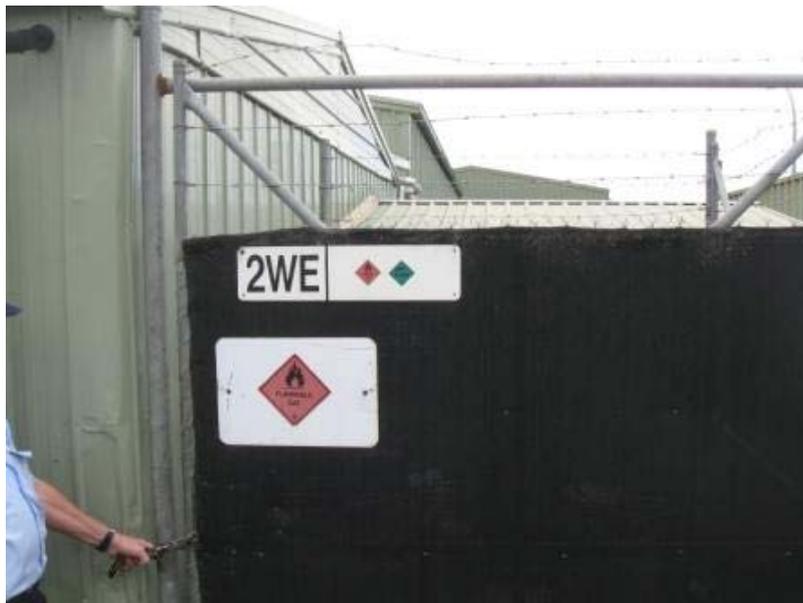
A gas store is located next to the workshop. **Refer photograph 3.** It has placards on it as it contains primarily forklift LPG. The placards are not necessary although some information on the nature of the hazard should be placed on the fence. The potential for gas leaking into the workshop is slight due to the gaps in the wall. They should be filled to eliminate this from occurring.

Photograph 3 Gas store placard

5. Remove the placards from the gas storage and the BA filling room.
6. Place a HAZCHEM placard at the entry gate.
7. Remove the MSDS from the First Aid room and institute regular checks on the inventory.

8. Fill gaps in workshop to prevent the potential for gas entering.
9. Determine maximum aggregate quantities of unleaded as well as any blends with Aviation gas and any other Class 3 packaging group II products. If greater than 2500L, develop a manifest and notify WorkSafe in the approved method as per Schedule 3 of the Dangerous Goods Regulations 2011

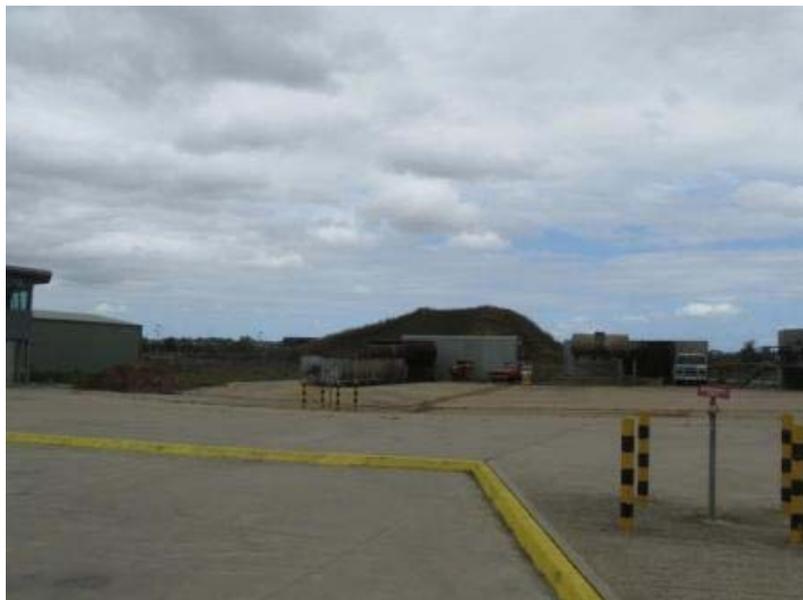
There are several PAD areas for fire fighting training exercises. The main area uses LNG as its fuel source. The prop fires are controlled from a control booth that can accommodate two supervisors running two different exercises. **Refer photograph 4** Wired controllers with dead man switches are also used as some of the exercises are not easily observed from the control booth. The instructors keep in radio contact with the booth controllers to add a further layer of safety.

Photograph 4 PAD and control booth

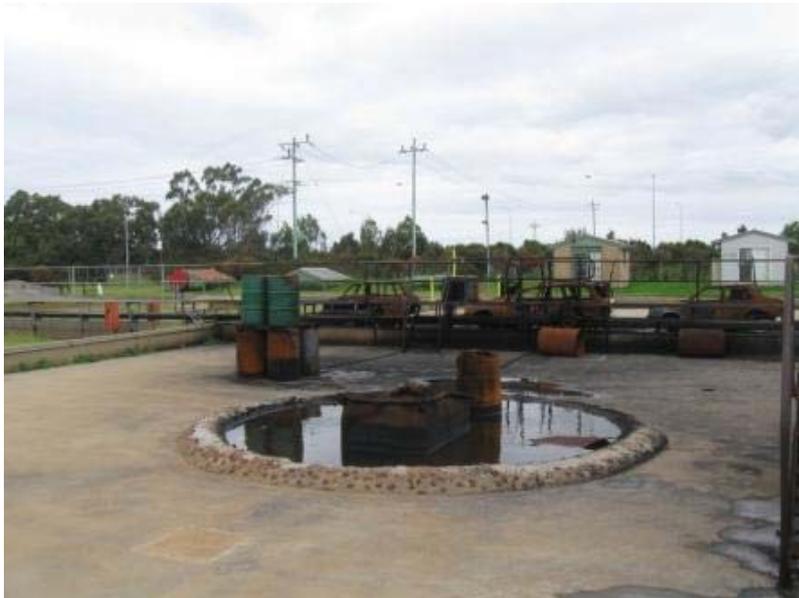
The other fire fighting ground utilised liquid fuels for the exercises. **Refer photograph 5** The fuel is generally a blend of ULP and aviation gasoline. Control over the fuel is similar to the gas PAD via a control booth although as the fuel is liquid, instantaneous extinguishment is not possible .

Photograph 5 Liquid fuel PAD

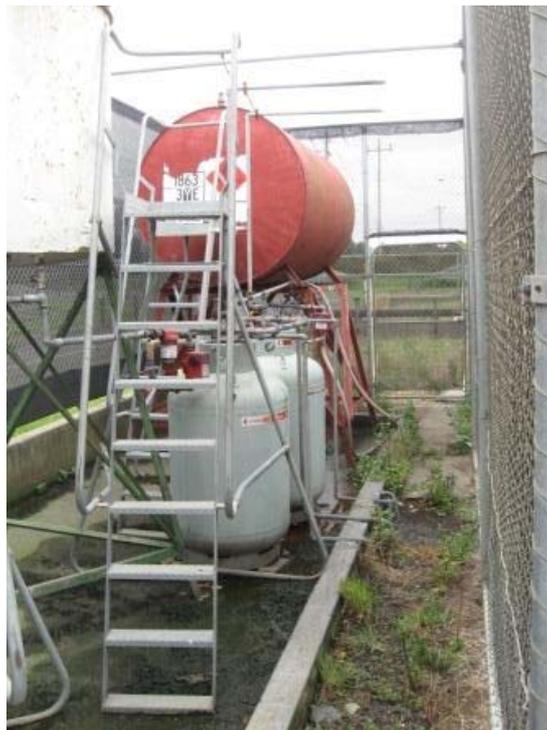
There is a bunded area that holds Aviation Gasoline, Unleaded petrol and diesel. **Refer photograph 6** There is 4000l of aviation gasoline and from a rough approximation, the bund has the capacity to hold 3500l. AS1940-2004 Handling and storage of flammable and combustible liquids recommends that the bund has the capacity to hold 110% of the largest container as well as 20mins of fire fighting water. The placement of the all the tanks do not comply with the requirements of AS 1940 as well as EPA bunding guidelines.

The total flammable liquids on the site are not at manifest levels as ULP is at 2400L which is only 100L below manifest levels form Schedule 2 in the Dangerous Goods Regulations (Storage and Handling) 2011. One thing to note is that when ULP is blended with Aviation Gas, the blend acquires the same packaging group of ULP and this could possibly exceed manifest quantities.

Photograph 6 Inadequate bunding

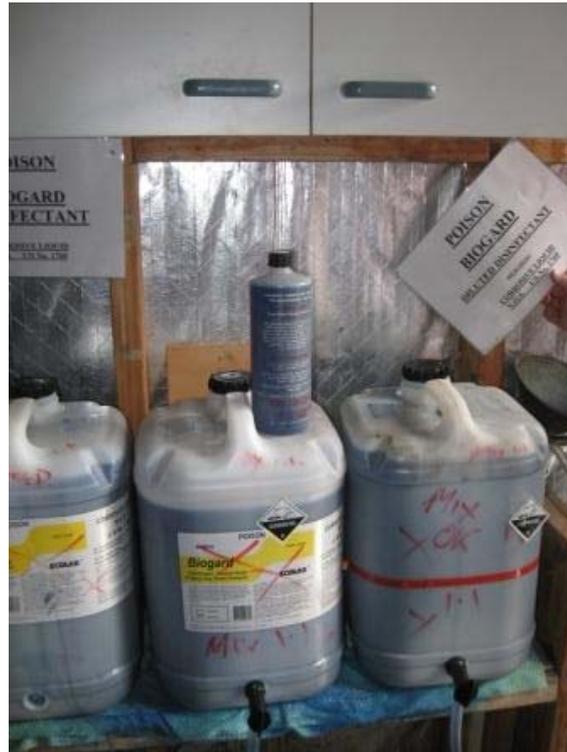
The site also provides diluted Bioguard, a quaternary (BENZALKONIUM CHLORIDE) compound used for disinfecting BA equipment across all CFA sites. The instruction on the wall is to dilute 1:1 with water before packing the blend into 1L bottles. The label on the original packaging indicates that it is a corrosive liquid. **Refer photograph 7** The concentration of the active compound is 230g/l. Based on information from the HSIS data base, hosted by SafeWork Australia, the dilution is insufficient to reduce the corrosive nature of the compound. The supply of this material should cease and a more diluted product of at least 1:2 product to water be made. The containers should be labelled, as a minimum, with the risk phrase of Irritating to Skin and Eyes and a Safety Phrase of Wear eye protection and suitable protective clothing.

Photograph 7 Disinfectant blends

1. Cease the distribution of the diluted Biogard as soon as possible until a safer dilution rate can be confirmed. Ensure labelling meets the OH&S Regulations 2007 or the Code of practice for the labelling of workplace hazardous substances.

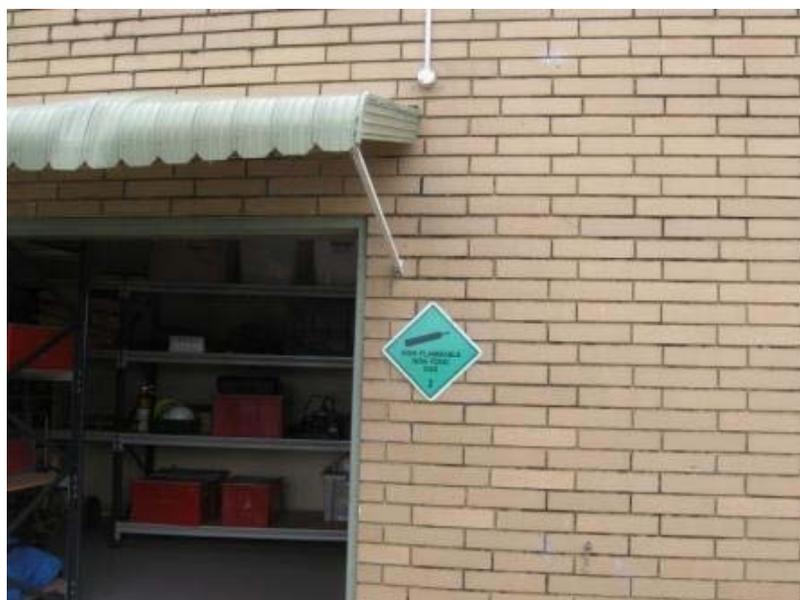
The BA cylinder filling and storage room contains only a maximum of 400L of compressed gas. **Refer photograph 8** The placard on the door is unnecessary for this quantity.

Photograph 8 Incorrect placard.
