HAZCON Pty Ltd

HEALTH AND SAFETY REVIEW – CFA WEST SALE TRAINING COLLEGE

Report Number: 12-0260 Final

February 2012

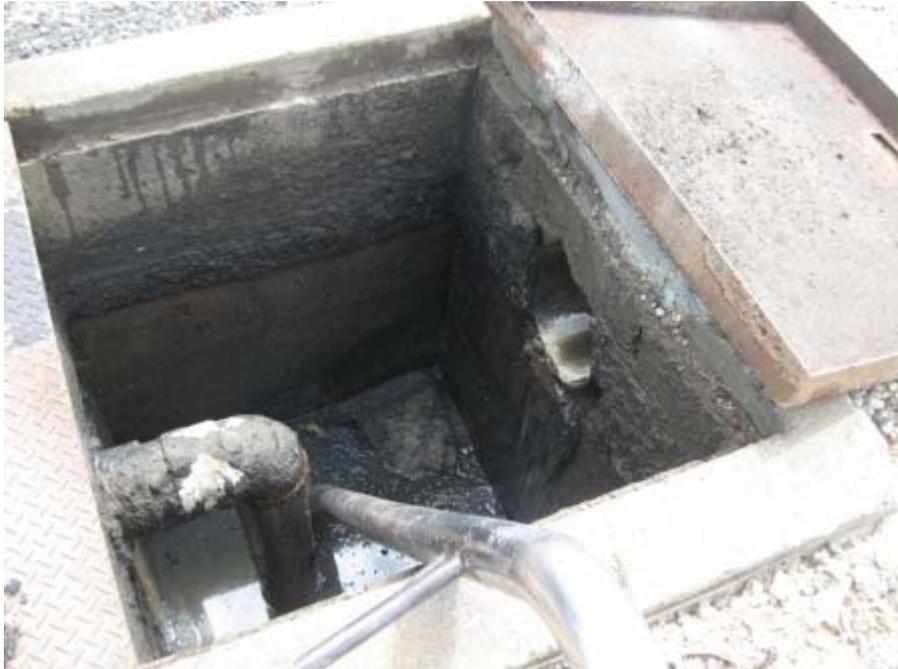
Photograph 1 Triple Interceptor

The water quality at the site is a cause for some concern as the dam into which bore water is pumped for fire fighting is also used to capture run off from the PAD areas. A triple interceptor captures contaminated water but would only prevent solids from passing into the dam, not the low density liquids such as hydrocarbons etc. **Refer photograph 1** It would not be able to cope with large rain events as the PAD surface area is large and the triple interceptor has limited retention capacity. The water is tested regularly and if the testing fails, there is no clear corrective action process in place. On the day of the assessment, the dam had been pumped empty of water and the residue was being excavated due to high bacteria counts. **Refer photograph 2**

Other than pumping out all the water from the dam, there is no clear corrective action to address poor water quality. A standard chemical dosing process with validation testing may be more appropriate to prevent having to drain the dam each time a high result is obtained

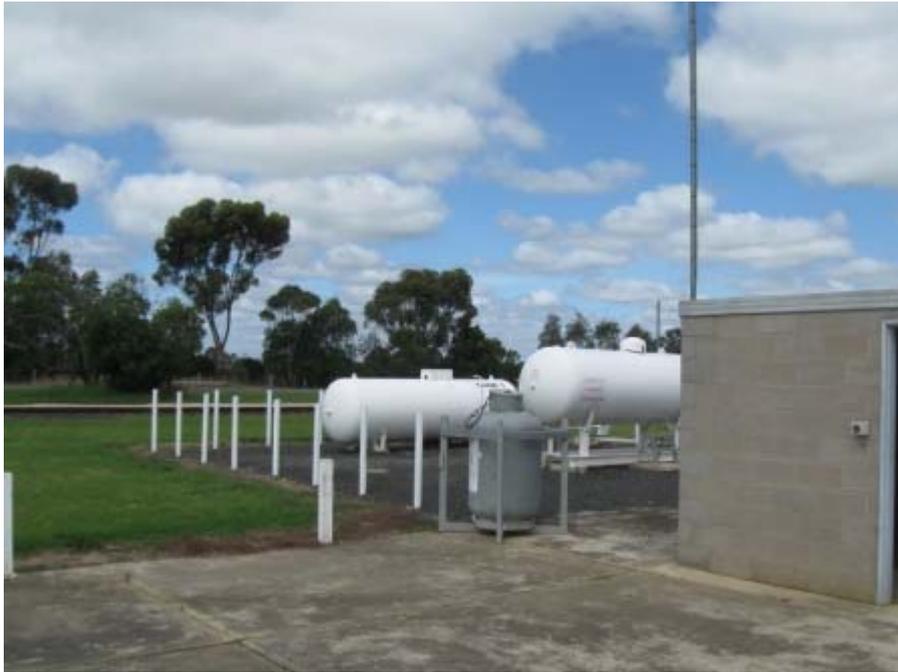
Photograph 3 Manifest levels of LPG

The site holds mainly fuels located either in a secure area or in two large LPG bulk containers. **Refer photograph 3.** A diesel tank is located next to the pump house and is clearly labelled. The site also has acquired out of date aviation gas to supplement its fuel needs. The aviation gas should be added to the dangerous goods register. **Refer photograph 4**

There is LNG supply into the Esso Sea Survival Training Centre and the CFA should consider tapping into this fuel source which would easily replace the LPG. This would reduce the actual fuel held on site, eliminate the need to transport LPG onto the site, eliminate the requirement to develop a manifest and eliminate the need to notify WorkSafe.

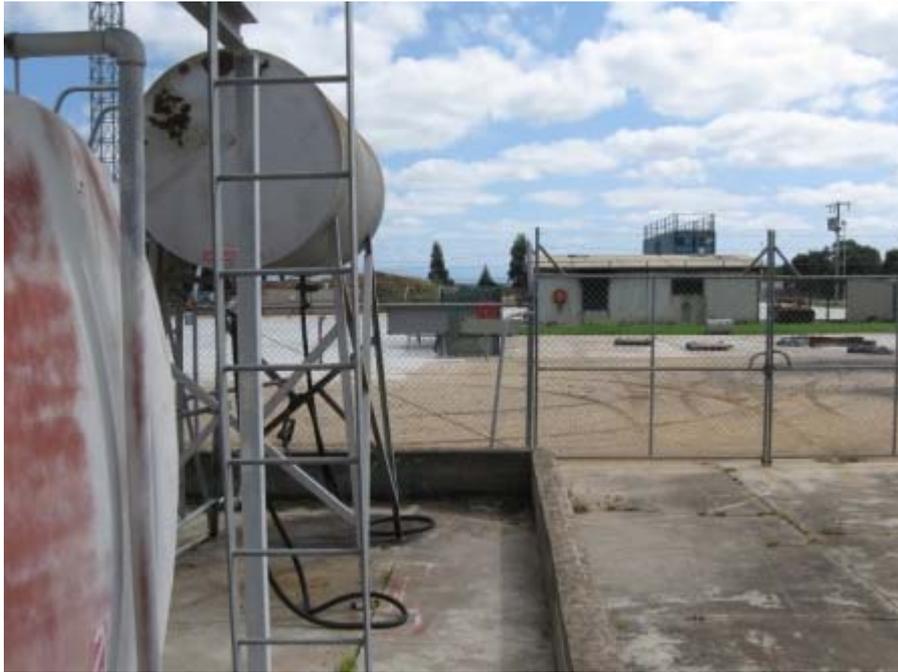
There is a dual petrol and diesel tank in a bunded area. The tank appears to be too close to the edge of the bund, based on AS 1940 recommendations. **Refer photograph 5** The edge of the tank must be greater than 1m from the interior edge of the bund and the angle from the crest of the bund to the edge of the tank should be greater than 27.5° from the vertical. i.e. 2 high : 1 wide. Note Figure 5.2 in AS 1940.

Photograph 5 Possible inadequate bund design

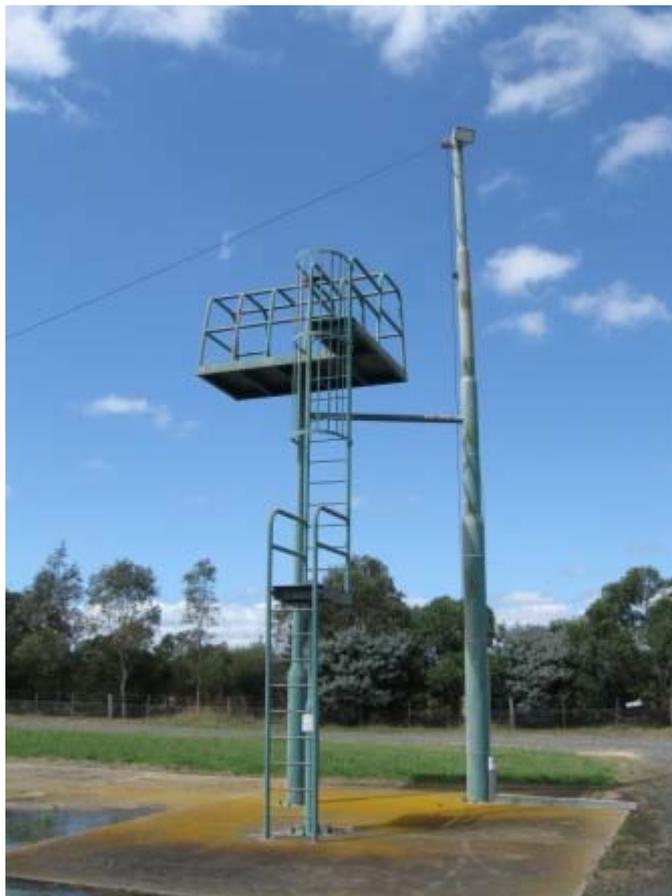
There is a parachute jump tower that has limited security in access to the platform. **Refer photograph 6** A locked gate should be fitted to the cage.

Photograph 6 Unsecure parachute platform

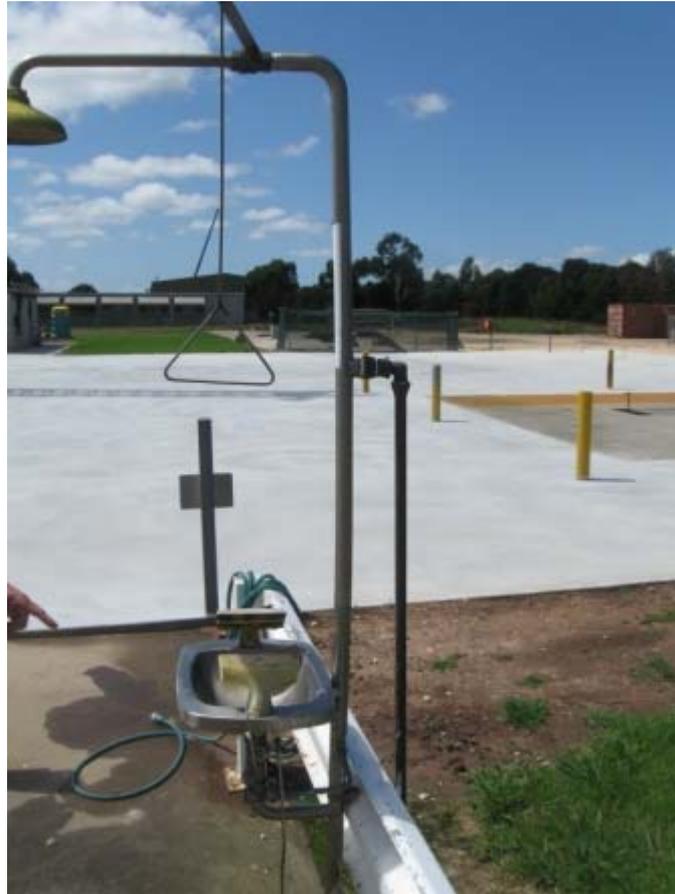
An emergency eye wash/shower station did not run as designed and the pipe work is exposed to radiant heat which may heat the water in the pipes to such a level that it may scald a person who uses it. **Refer photograph 7**

Photograph 7 Faulty emergency eye wash
