Report To:
Blake Dawson
HEALTH AND SAFETY REVIEW – CFA WANGARATTA TRAINING GROUND
Report Number: 12-0260 Final
17 February 2012

Mr Robert Jamieson of Blake Dawson, representing the CFA to provide legal advice, engaged HAZCON Pty Ltd to conduct a health and safety review of the CFA training ground located at Wangaratta, Victoria.

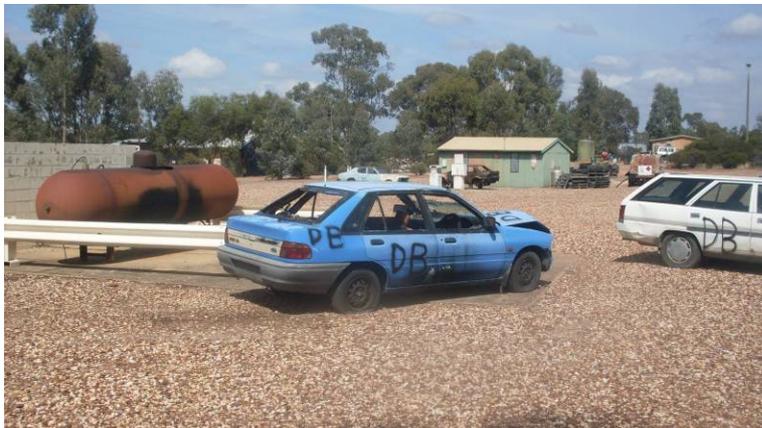
Photograph 1 LPG PAD

The bulk LPG tank exceeds manifest quantities as per Schedule 2 of the Dangerous Goods Regulations 2011. WorkSafe should be notified as per the relevant regulation.

1. Update MSDS folder to ensure MSDSs are no older than five years.
2. Considered undertaking risk assessments for hazards and risks that are not included in PAD briefs and SOPs.
3. Review content of the Plant Register to ensure it is current.
4. Consider formalising/recording some of the tasks the Training Ground Manager undertakes to capture and retain this knowledge.
5. Consider formalising processes such as the use of checklists to demonstrate that each hazard and associated control for individual training sessions has been considered and applied.
6. LPG gas is at notification quantities.

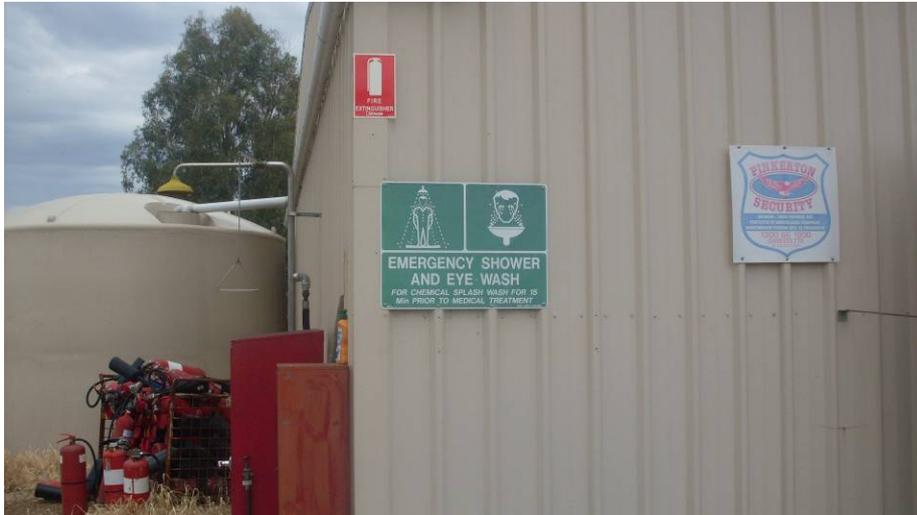
Photograph 3 Emergency Shower

An Emergency eye wash and shower station was available.

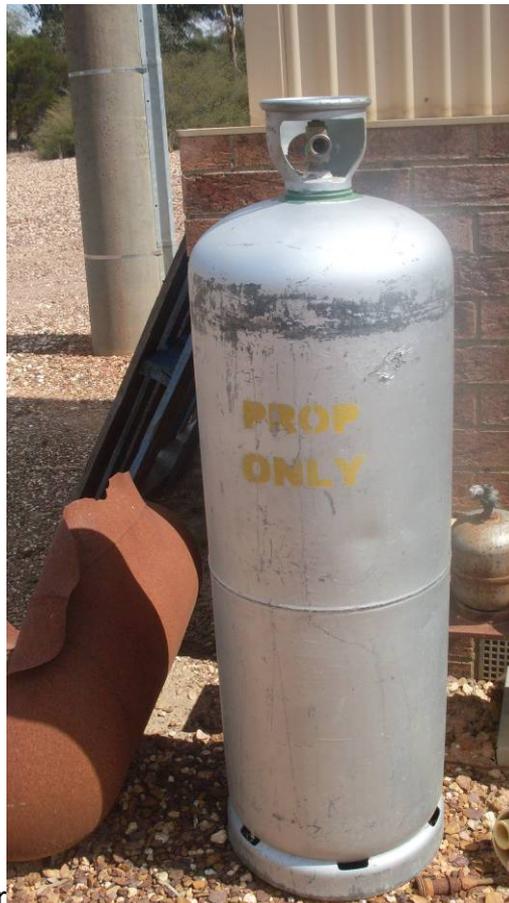
Photograph 4 Prop Gas Cylinder

Chemical containers and cylinders used in training exercises have been cleaned and clearly labelled as a 'prop'.

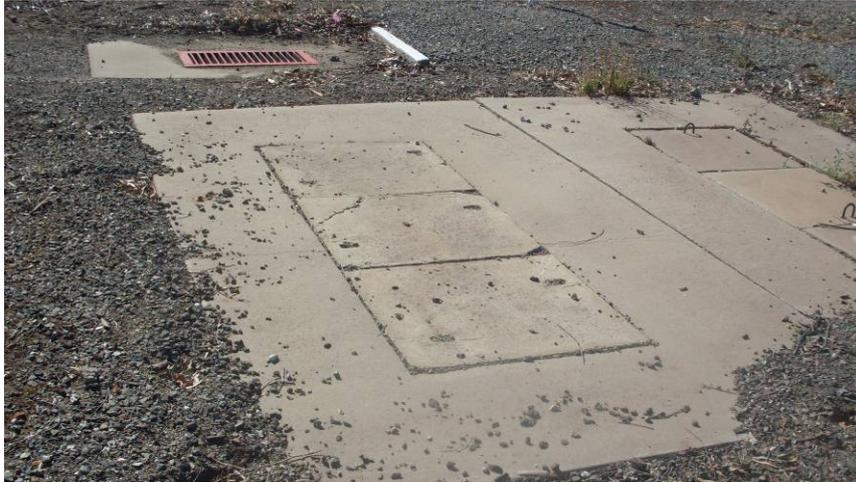
Photograph 6 Triple interceptor pit for fire water run-off

Contaminated water from exercises drains into a triple interceptor that then drains into a nearby creek. Water quality is monitored and a formal six monthly inspection regime to determine water quality is undertaken with reports sent to the EPA.
