Land Use Planning Case Study

The benefits of perimeter roads in strengthening community resilience to bushfire

James Hird Estate, Hastings

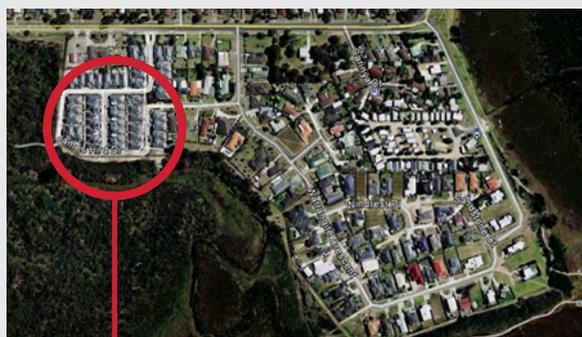
Before the 2015 bushfire

Perimeter road provided as a result of CFA input

- In the areas where a perimeter ring road did not exist, a fire road access track be created between the properties and the bushland
- Stage 2, and subsequent development, would now incorporate a perimeter ring road, with additional vegetation management to occur between the road and the bushland; and
- Conditions were included for management of the vegetation between the development and the property

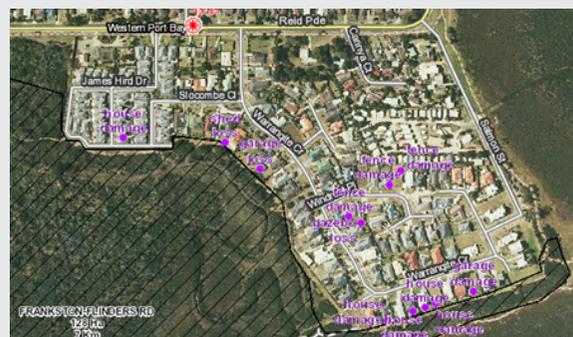
After the impact of the bushfire

Area impacted by bushfire Structures lost

- Fire crews used the perimeter ring road to fight the oncoming fire resulting in the protection of homes on the south-west edge of the development; and
- Where there was no perimeter road, significant loss of fences and impacts upon buildings occurred in the parts of the estate directly adjacent to the bushland.

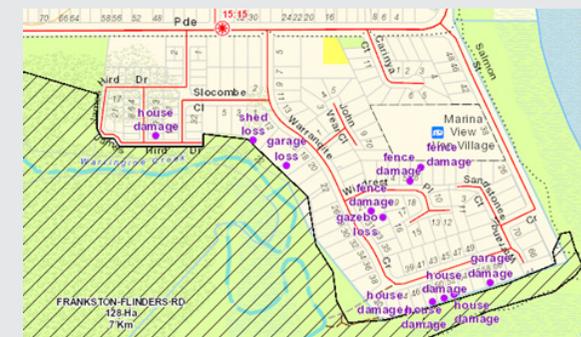
Area impacted by bushfire Structures lost
