Fiskville

Understanding the Past to Inform the Future

Report of the Independent Fiskville Investigation

June 2012

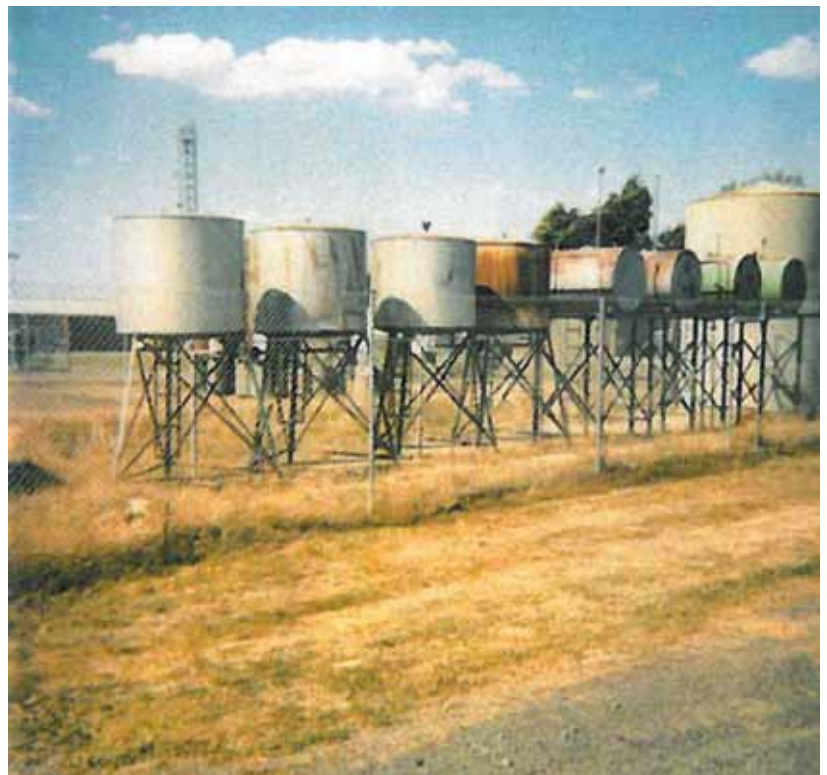
- drum burial area - south of the airstrip and Deep Creek Road
- drum burial area east of the administrative building
- drum burial area north of the administrative building
- historical and current above and below ground fuel storage tanks
- the two closed landfills.^[7]

**Above ground fuel storage tanks, 1996.
Photograph courtesy of CFA**

Golder Associates consultants recommend further assessment of groundwater and soil quality particularly in the following areas not included in the site assessment phase:

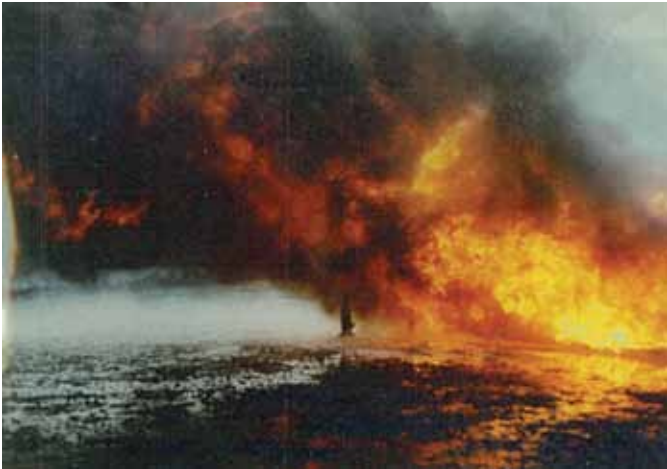
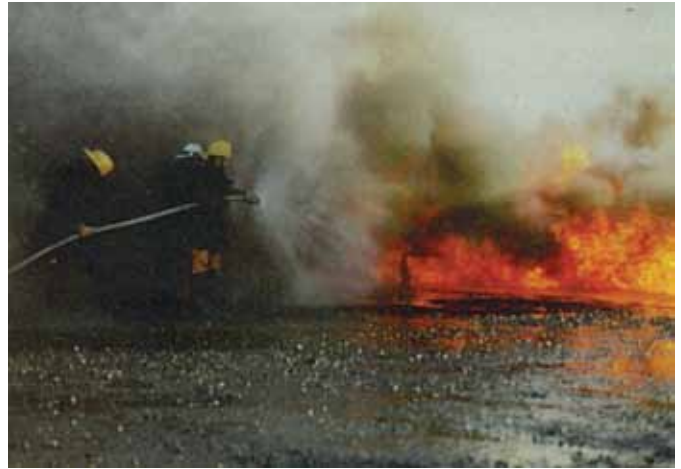
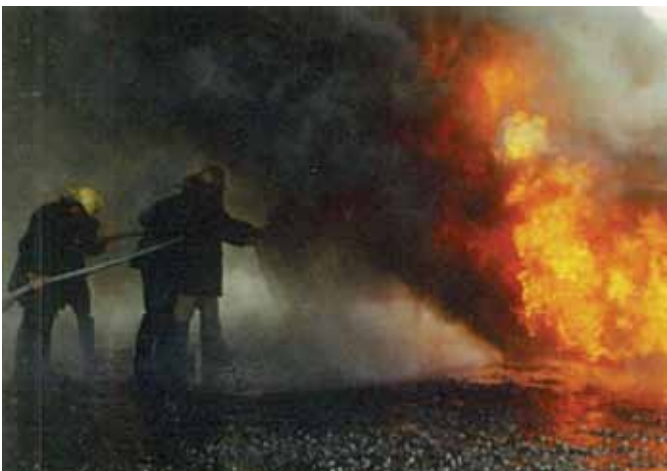
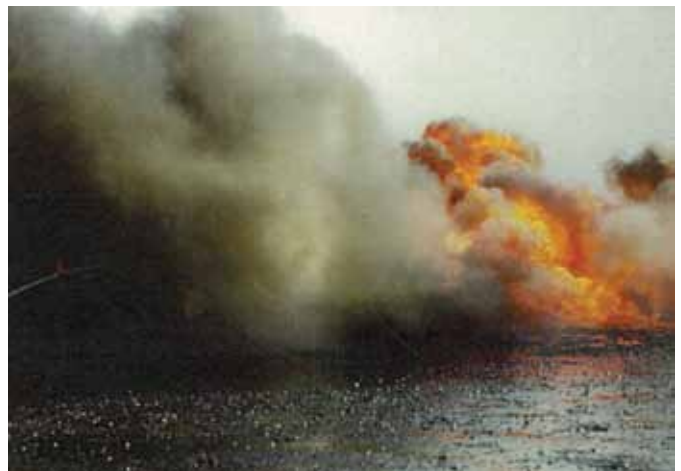
At Fiskville, ingestion of toxic substances (hydrocarbons, foam breakdown products – PFOS and PFOA - and particles) is most likely to have occurred through the unintentional swallowing of liquid aerosols associated with the occasional use of recycled fire water from the back-up safety system.^[3-5] Clean, portable water was the primary source of firefighting water. Ingestion is considered to be a significantly less important exposure route than inhalation.

Series of two line fog attack drill, downwind of smoke circa 1980s. Photographs courtesy of Paul Blythman
